# Failure of an M24 Engine Mounting Bolt

**Inadequate preload can result in fatigue failure from joint movement and eventual self-loosening of the fastener.**

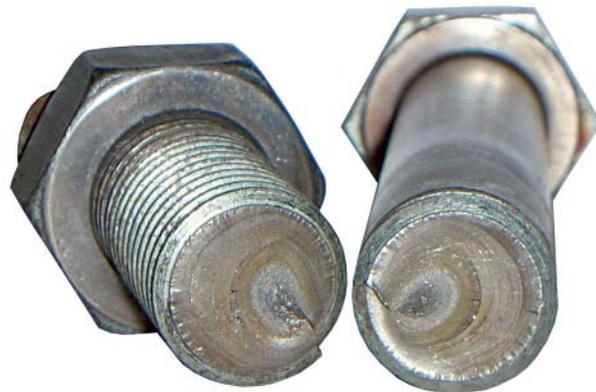
Fatigue failures continued to be experienced. A failed specimen is shown in **Figure 1**, **Figure 2** and **Figure 3**. In this example, the fatigue failure occurred in the runout region of the thread. **Figure 2** displays the failed section of the bolt, indicating that the failure could be attributed to bending fatigue. **Figure 3** shows the nut had backed off resulting in the split pin being partially sheared.

Fig. 1 — Specimen of failed bolt from bus chassis.

The bolt failure that is illustrated in **Figure 1**, **Figure 2** and **Figure 3** exhibits the two effects of self-loosening and fatigue.

To resolve the issues of specifying a tightening torque that was achievable, given the tools and space limitations of this installation, while ensuring adequate preload, it was decided to reduce the size of the bolt and to increase the bolt's strength. As a result, an M16 flange headed property class 12.9 bolt was specified.

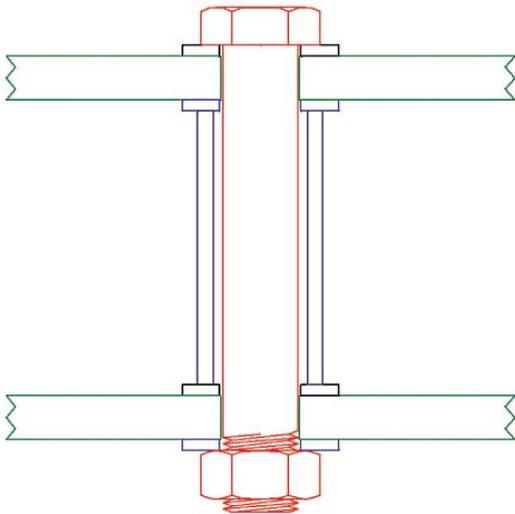
A section through the joint is shown in **Figure 4**. As can be seen, the joint consists of several sections, some of which are steel and others aluminum. The forces acting on the joint comprise both dynamic axial loading from the weight of the engine and lateral loads as a result of braking, acceleration and cornering forces.

An investigation and analysis of the joint was completed. The several layers of the joint contributed to a loss of preload as a result of embedding (plastic deformation of the contact asperities subsequent to the completion of the tightening process). A joint analysis was completed and indicated that when the scatter from the tightening process was included, a proportion of the joints would fail to provide sufficient preload to resist the forces applied to it. The preload requirement chart as a result of this calculation is shown in **Figure 5**. Because of this, in such joints small lateral displacements could be anticipated to occur. Repeated lateral displacements would have two effects:

Fig. 3 — Backed-off nut resulted in the split pin being partially sheared.

Fig. 4 — Section through the joint showing several sections, some of which are steel and others aluminum.

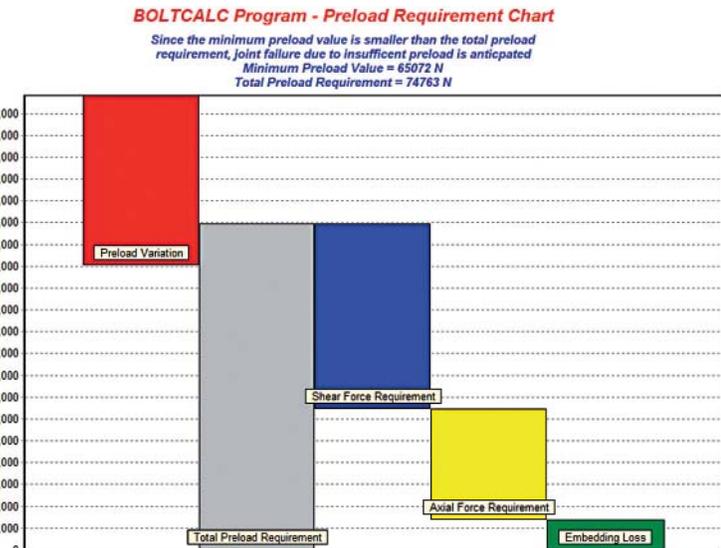
A joint analysis indicated that achieving the correct tightening torque would ensure that a preload would be reached that would be sufficient to prevent joint movement that was considered to be the root cause of the problem. However, it became apparent that on production assembly and when vehicles were being maintained in service, that consistently achieving the 660 Nm (487 lb-ft) tightening torque would be problematic.

Fig. 5 — Preload requirement chart resulting from joint analysis calculation.

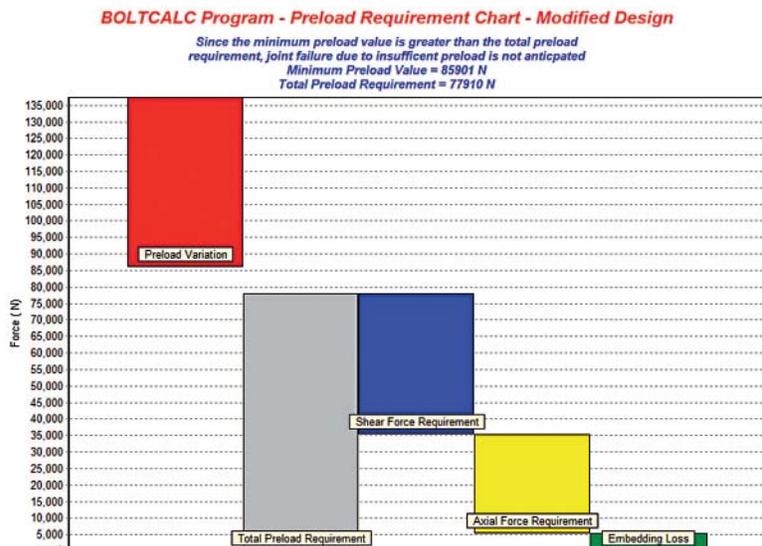
Fig. 6 — Preload requirement chart for modified design.

Torque was specified at 380 Nm (280 lb-ft), which with torque was anticipated to produce a preload variation of between 86 and 137 kN (19,330 and 30,800 lbf). The minimum preload required was 78 kN (17,535 lbf), which is below the anticipated preload range for the modified design. For this reason, further fatigue and nut loosening issues were not anticipated. The preload requirement chart for the modified design can be seen in **Figure 6**.
